Modifications to the Nab Detector Electronics System

Andrew Hagemeyer

ACNS Conference, June 26, 2024

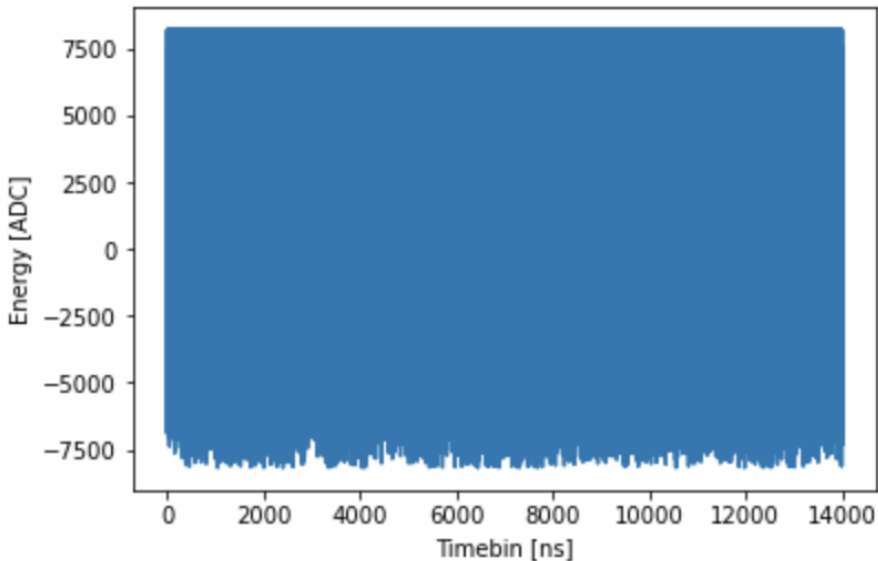
Oscillating Preamps Waveform

- Stability
 - Too many preamps plugged in leads to system oscillations
 - Preamps too cold leads to oscillations
 - Damage can lead to loss of pixel or instability

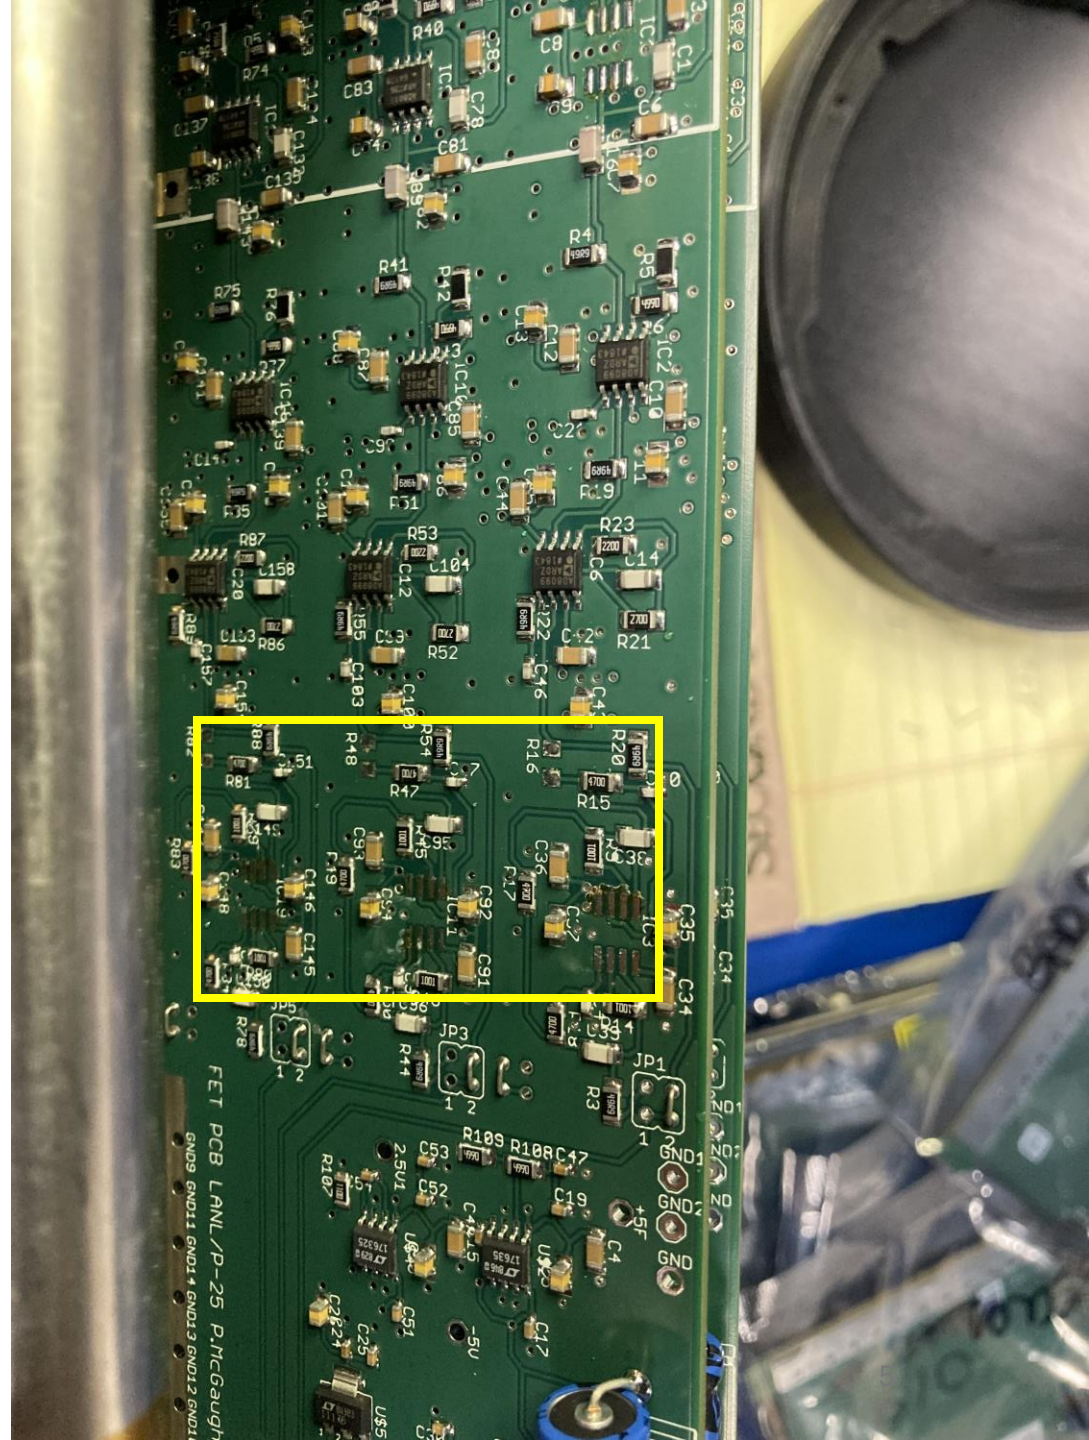
- Shaper Circuit Removed
 - Not in currently used
 - Preamplifier board power draw reduced by 1/3
 - Before
 - +7V : 295 mA
 - -7V : 271 mA
 - After
 - +7V : 211 mA
 - -7V : 186 mA
 - Stability Test
 - All preamps powered, system did not oscillate on bench for 2 hours

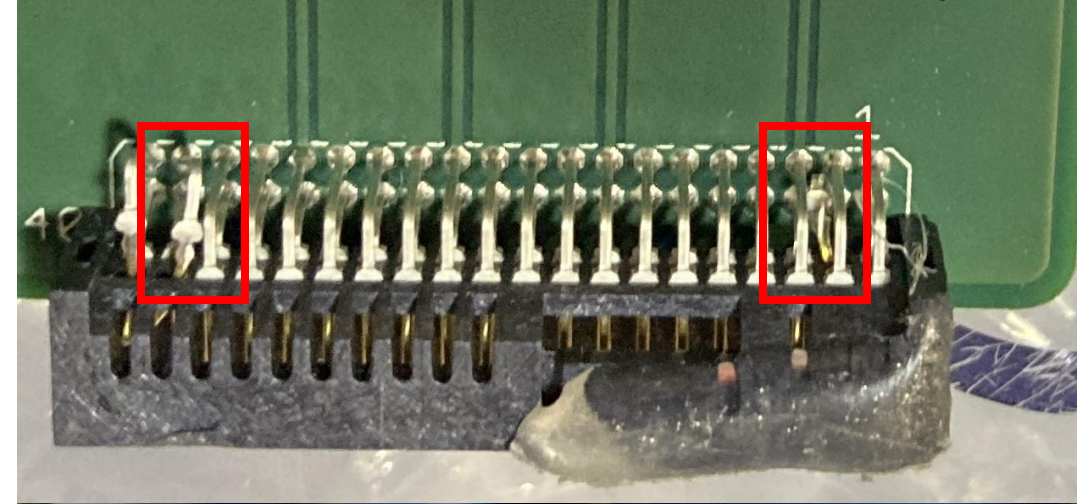
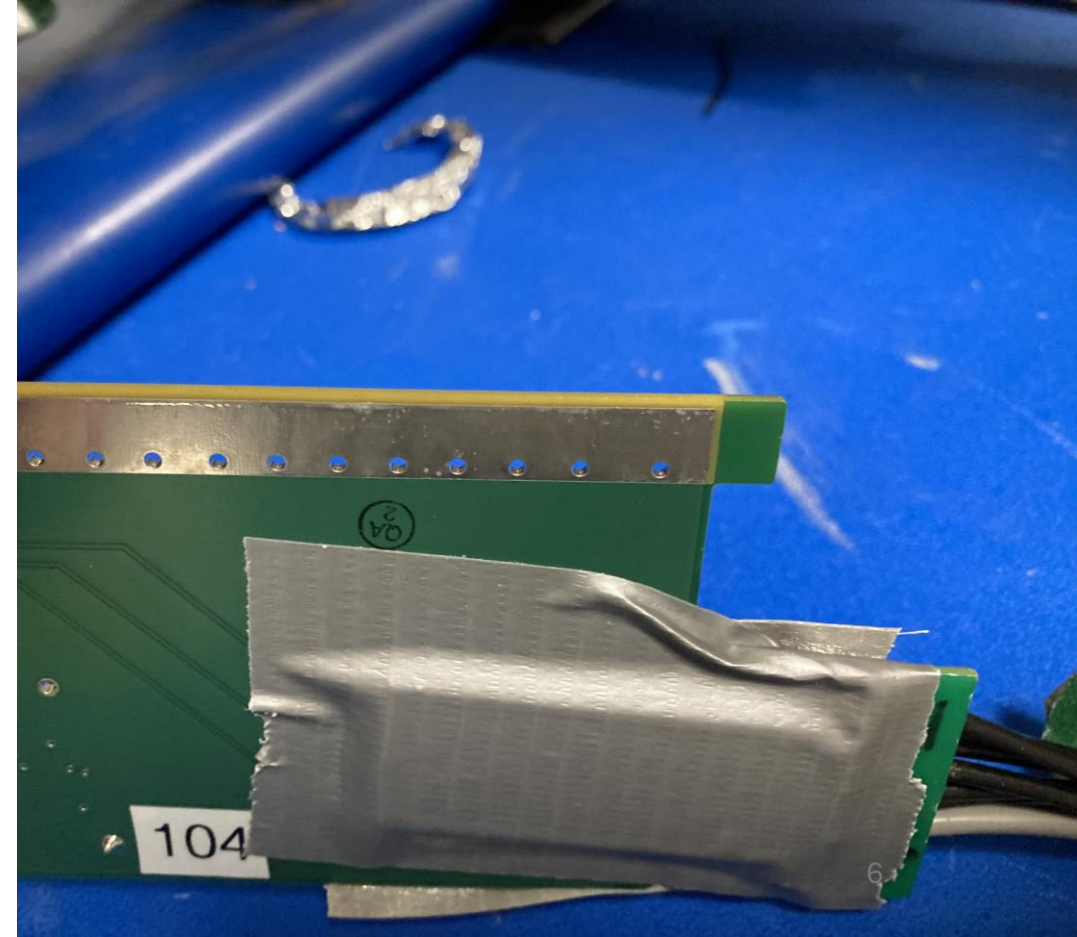
Connector Issues

- Connector Damage
 - Movement of Pins
 - Touching other Pins, not Pushed in
 - Connectors disengage easily
 - Tabs taped to connectors, holding them together
 - Repair Difficulty
 - No thermals on ground pins makes replacement effectively impossible

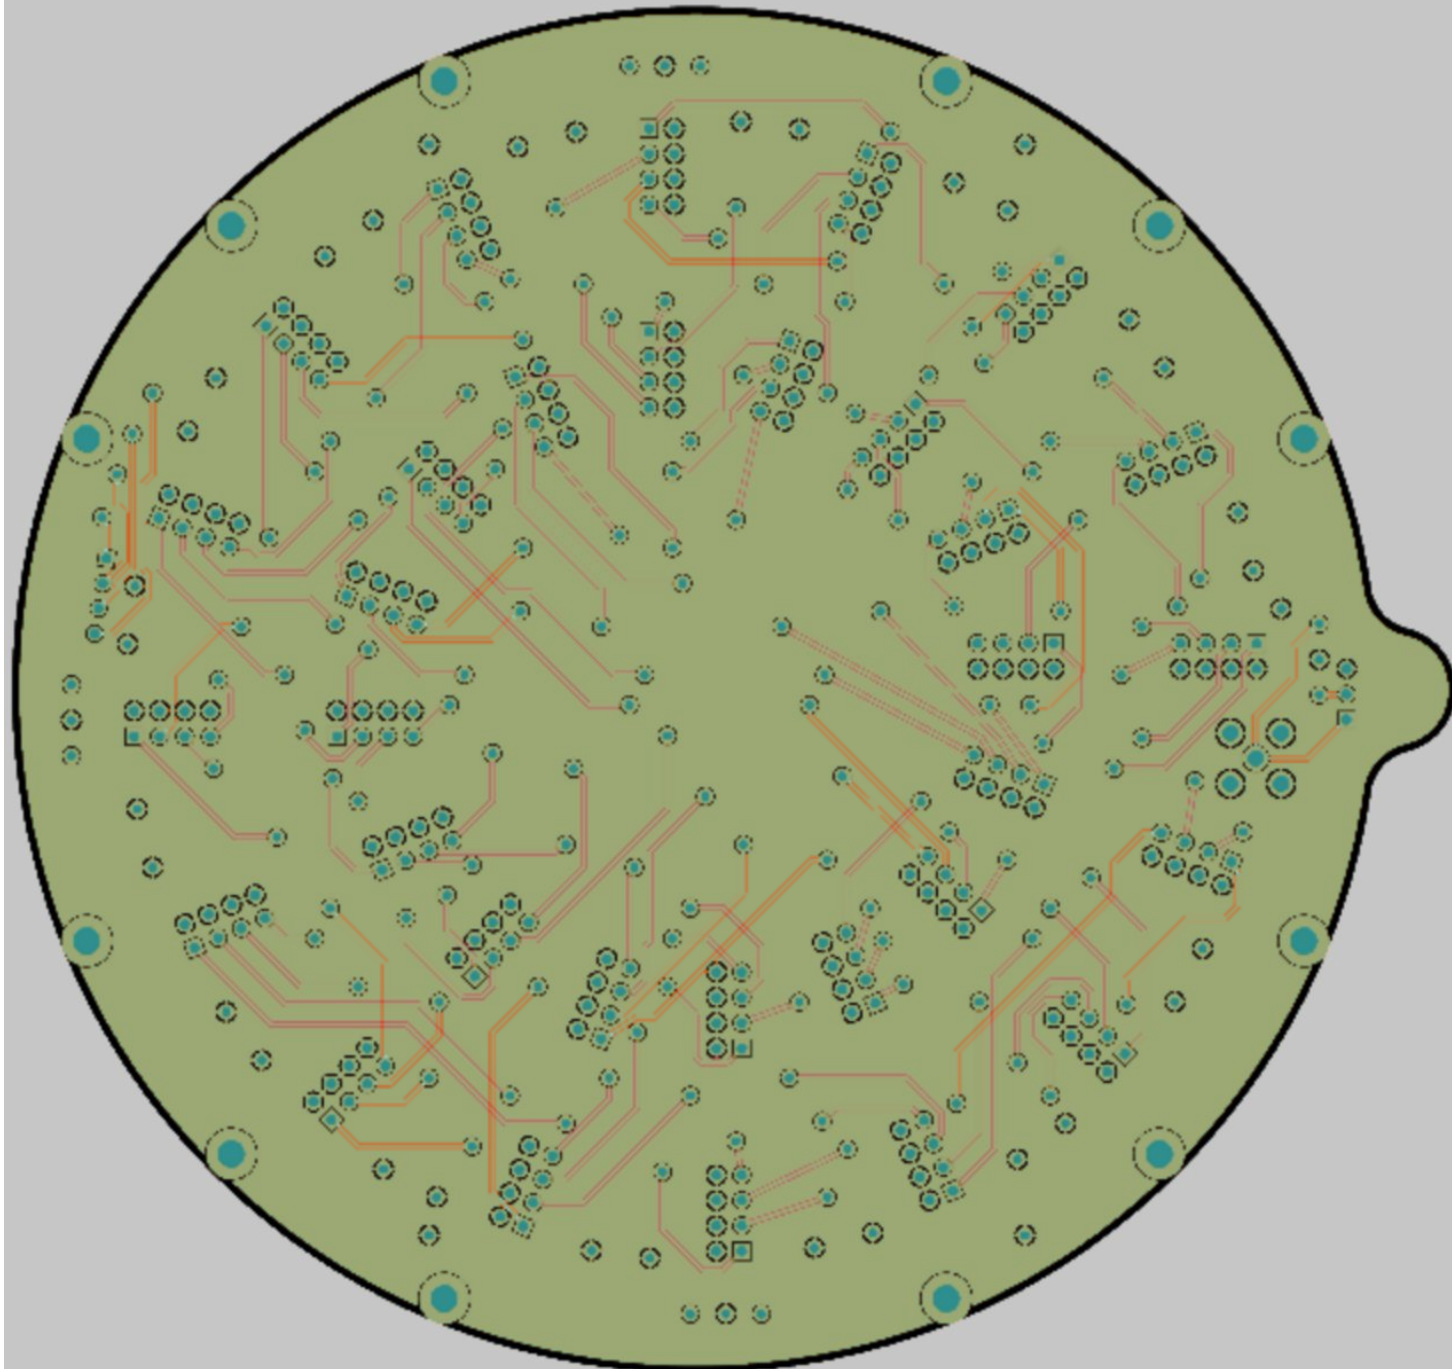
FET Pogo Pin Board Cross Talk Bench Test

- Tested Overlapping Traces looking for crosstalk
 - 1 V output signal saw less than 10 mV crosstalk

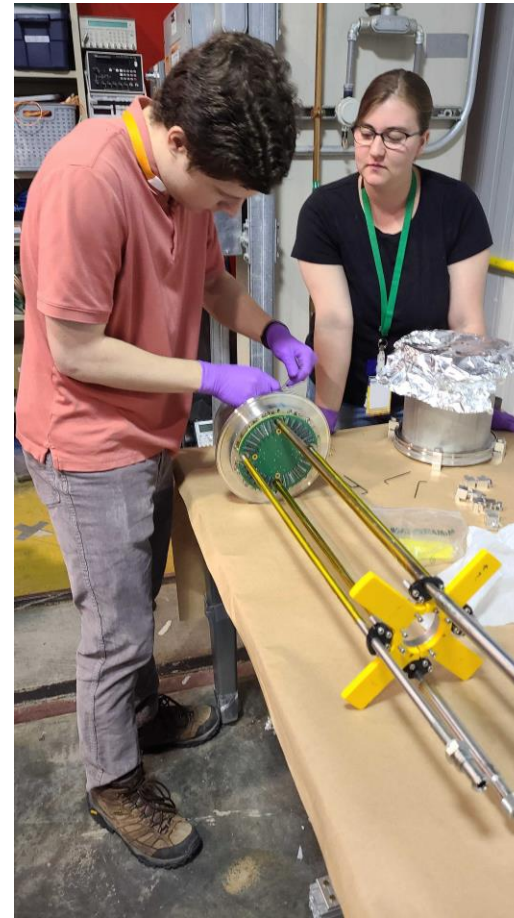
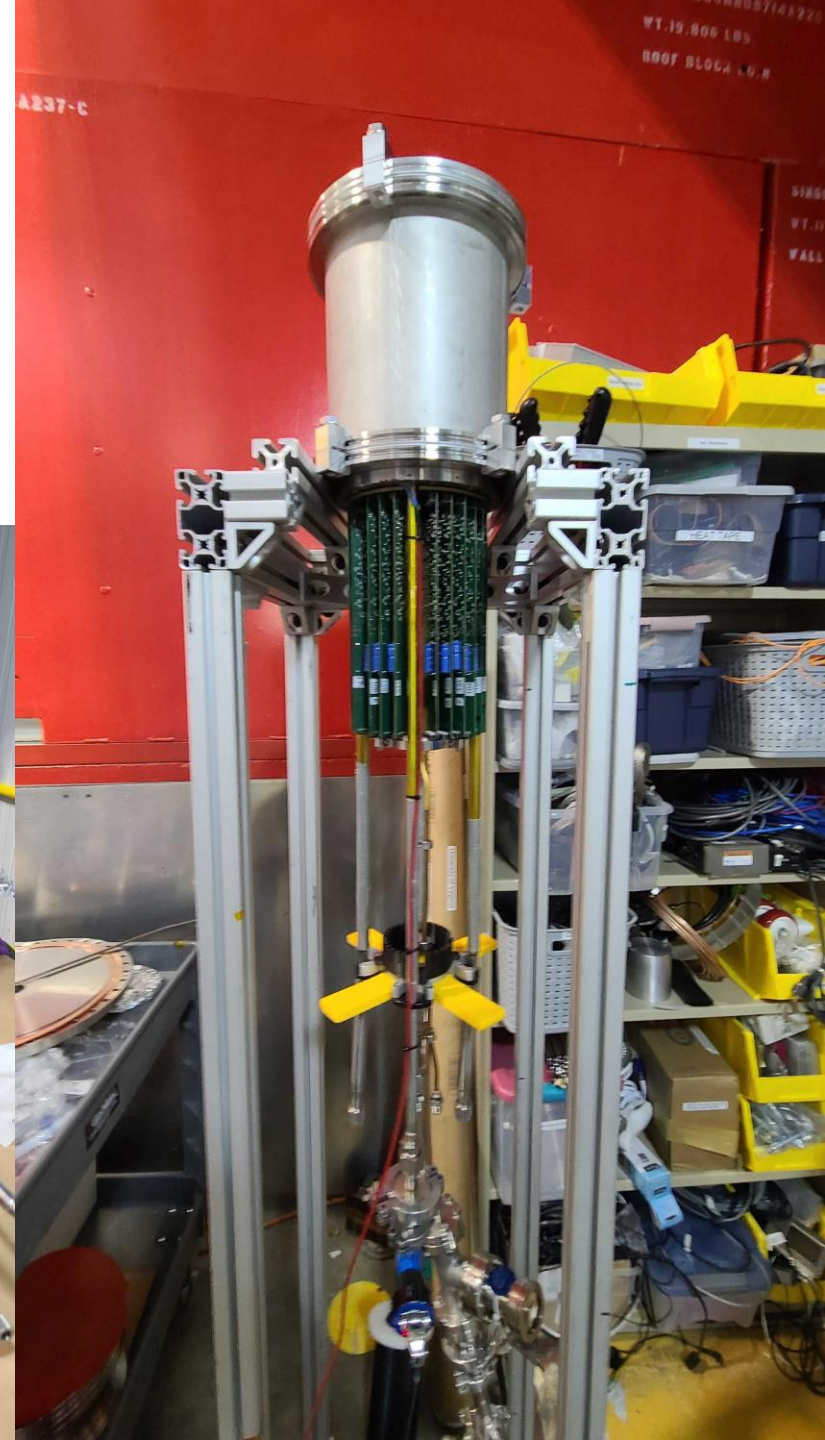
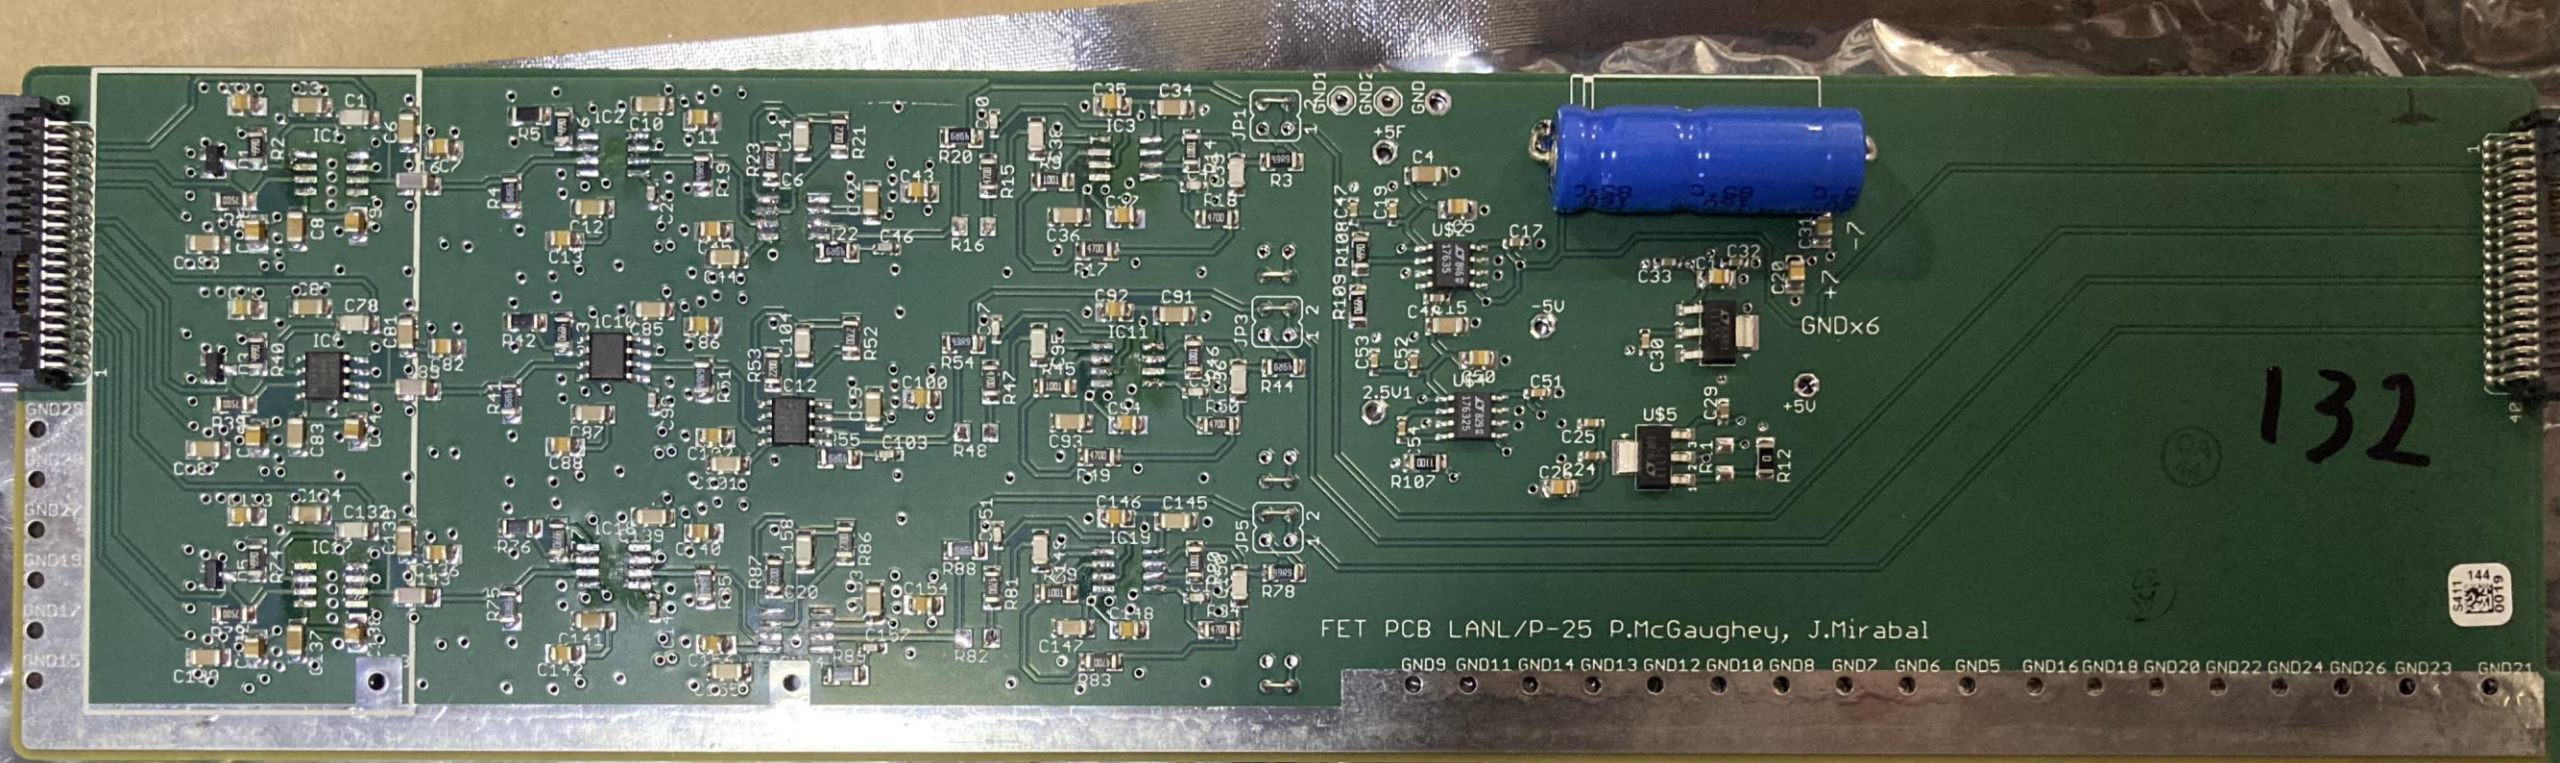
Mini Chamber

- Tests of Electronics Changes
- Testing for new Lower Detector
- Testing of New Transition Boards

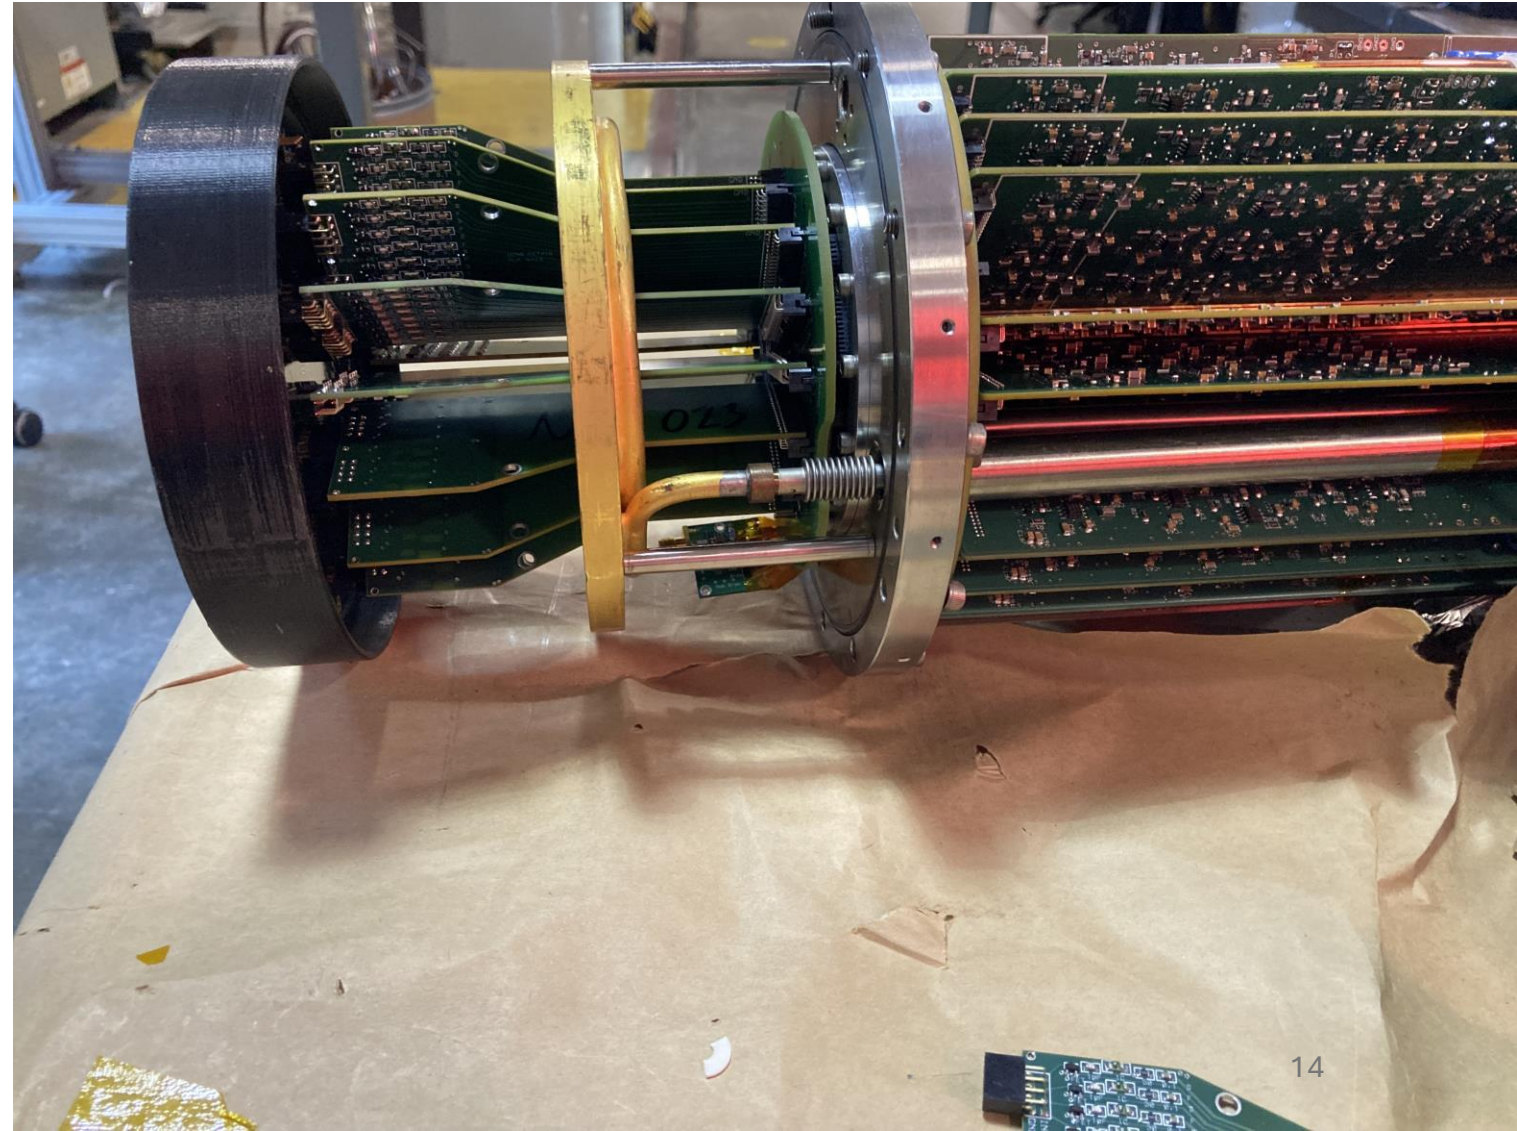
FET Card Removal Bench Test

- Removed four FET cards (32 channels) from Electronics system to test stability

- FET removal test:
 - System oscillated 4 times in 90 minutes
- Op-Amp removal test:
 - System oscillated once in 24 hours
- Bench Test,
 - No Detector
 - FETs not cooled
